# Case Study: Monitoring for injectivity and integrity

Applying DTS to understand packer integrity and outflow performance with changing flow control device setting.

**Location:** United Kingdom  
**Well Type:** Water Injector, Subsea horizontal well  
**Analysis Date:** May 2021

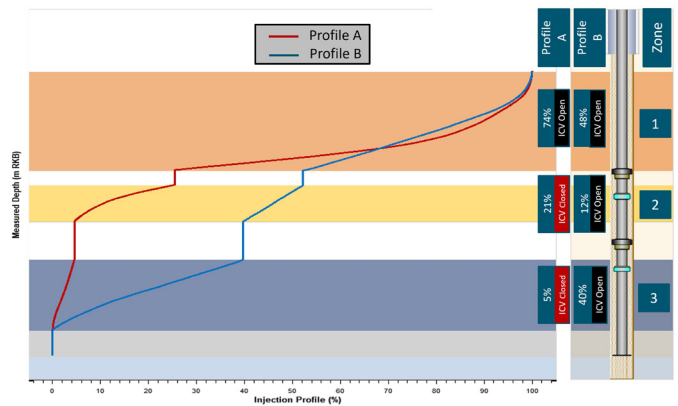
Figure 1: Outflow profiles

The outflow profile for two different periods in the well were provided and it showed that when ICV position changed, the outflow profile in the well changed accordingly.

It also confirmed that the deepest isolation packer was leaking because the ICV in that zone was closed but injected fluid still made its way there.

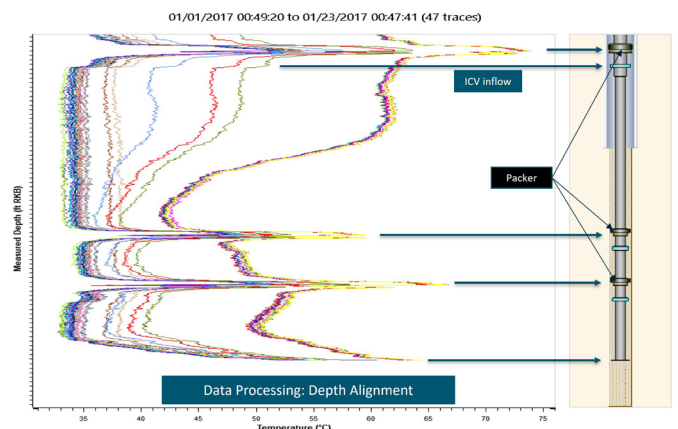
Figure 2: Depth alignment

The Software FloQuest was used for data processing. The processing carried out included trimming off excess data before the well head and depth shifting the traces so that recorded events align with the completion diagram.
