Case Study:

Encapsulated O-Rings seal the deal for injection well in the Netherlands

Encapsulated O-Rings prove to be the ultimate sealing solution during gas injection for dutch operator.

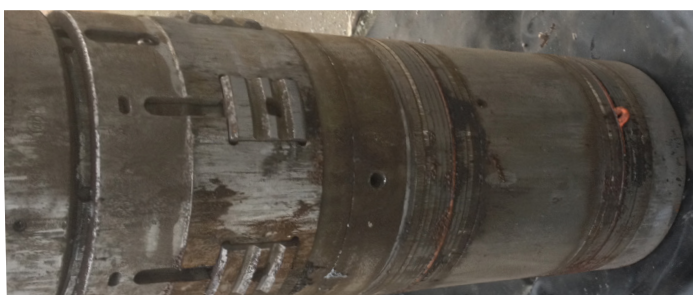
Injection sleeve retrieved from well with Encapsulated O-Rings still intact.

Throughout gas injection in Well A7B, Tendeka's Encapsulated O-Rings successfully sealed the injection sleeves which showed no signs of leakage. The sleeves were later retrieved from the well through slickline intervention where they were cleaned and evidently showed that the O-Rings were still in tact.

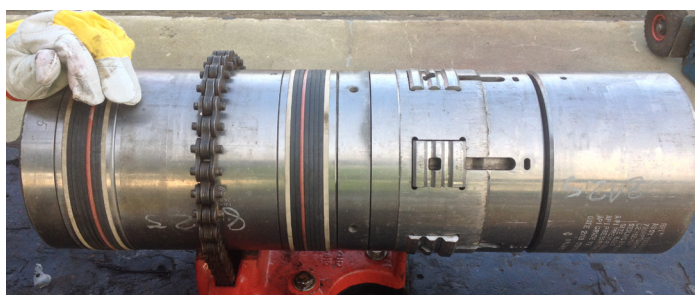
Injection sleeve and Encapsulated O-Rings cleaned after retrieval from the well.
