## Case Study:

# SwellStack extends life of surface control sub-surface safety valve

Swellstack sealing system successfully restores production and maintains well integrity for global operator in the North Sea.

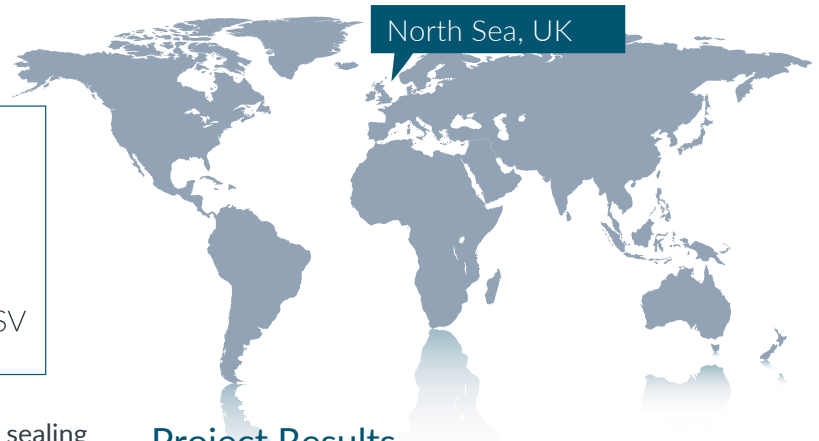
Tendeka designed and manufactured a swellable seal system as a direct replacement to the standard chevron seal stack. The resulting SwellStack packer opposite clearly shows deformation in the seal where the compound had adapted to the damaged seal bore profile.

Well integrity was regained and put back on production and the SCSSV was successfully retrieved on a 7/32" wireline. The well was flowed briefly to increase the surrounding temperature at setting depth, increasing swell performance and reducing time before the valve held pressure. By installing the SwellStack system, it extended the life of the safety valve and also avoided the alternative of an expensive workover that would have involved pulling the completion to replace the entire system. In conclusion, SwellStack proved to be a simple solution with minimal cost to the operator.
