Case Study:

Swellable O-Rings successfully reinstates function of safety valves

Swellable O-Rings help to get wells back on production successfully and faster by sealing badly damaged sealbores.

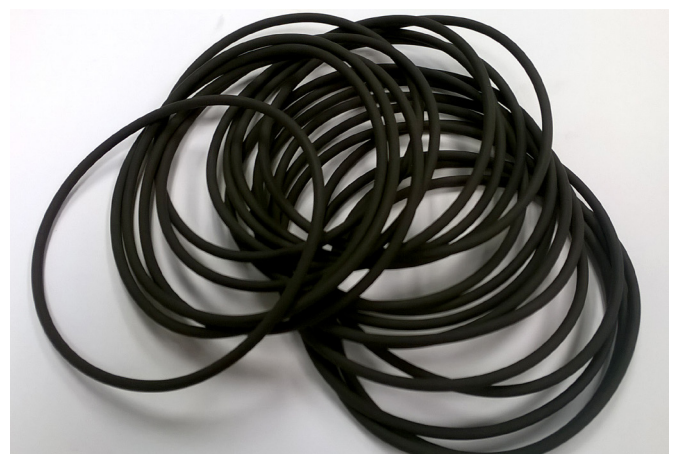
O-rings

Tendeka expanded their knowledge on swellable products to come up with the swellable O-ring. The O-ring replaced the existing male to male adaptor in the packing stack. Using the control fluid as well as the wellbore fluid, they swelled the rubber into the scored or damaged sealbore. This created a pressure tight seal to enable full opening pressure to the safety valve and restoring the well to production, saving time and cost on previous operations.
